# **SOMERSET VILLAGE**

## **HOA RESERVE STUDY**

Report Number: 10-003  
Site Inspection Date: September 14, 2010  
Report Submittal Date: October 1, 2010

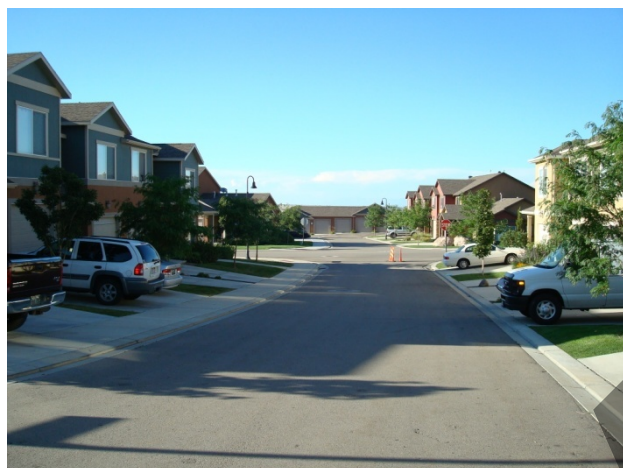
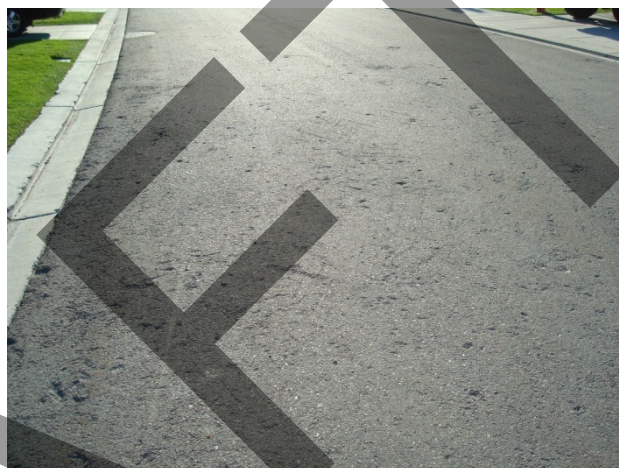
Component Name: 2" Asphalt Overlay  
 Component Number: Drive Materials 1001

It is our understanding the asphalt in phases I and II is 2-inches thick. Design thickness is 3-inches and will be placed the month of this report. Several areas in Phases I and II were in need of slurry seal or overlay at the time of observation. Asphalt in phase III was observed to be in adequate condition with areas containing minor cracking. No alligator cracking or longitudinal cracks wider than 1/4 inch were observed during the walk through in the phase II area. An asphalt overlay is recommended in 15 to 20 years. The overlay will add new structure to the road and fix any pot holes or structural defects that may develop over time. Without an overlay, the road will eventually break apart completely, requiring a total reconstruction.

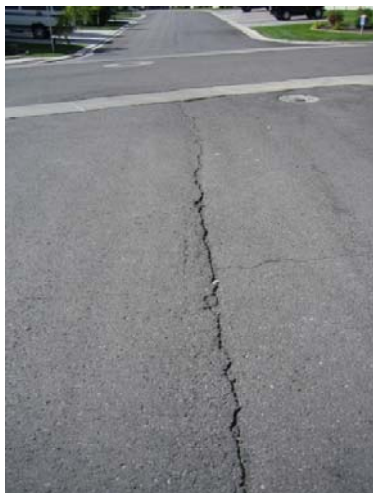
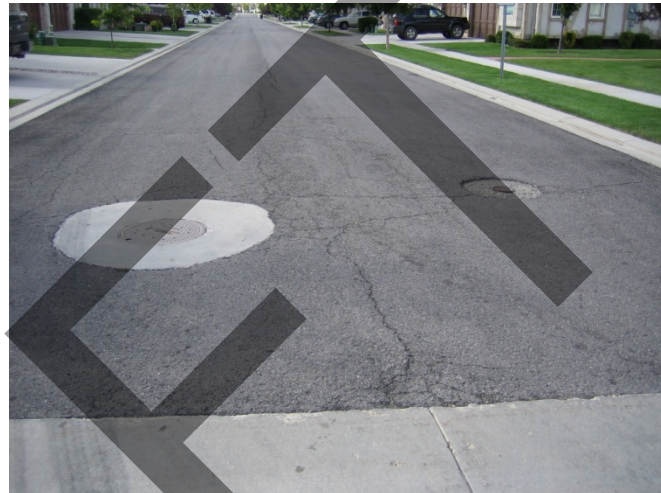
Component Name: Asphalt Slurry Seal  
 Component Number: Drive Materials 1002

The asphalt appeared to be in adequate condition with areas showing cracking. A slurry seal is recommended within the next two years. Slurry seal will help protect the asphalt from degradation by sealing cracks, preventing water seepage and damage. It also rejuvenates the surface and renews the oils, keeping the asphalt from becoming overly brittle.

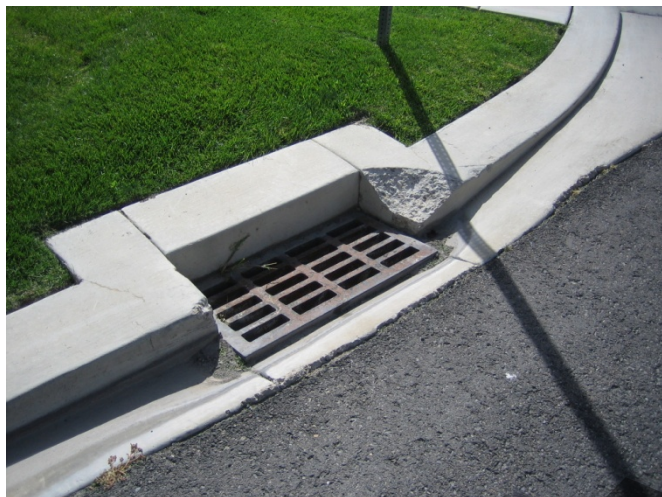
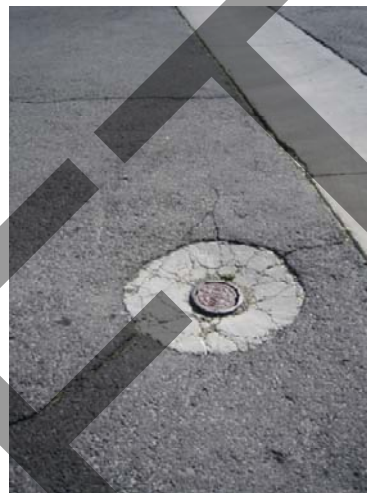
Component Name: Concrete Repair/Replace  
 Component Number: Drive Materials 1003

Component Duration			Component Cost			
Component Life Expectancy:	<u>N/A</u>	years	High Replacement Cost:	<u>\$20,000</u>		
Age of Component:	<u>N/A</u>	years	Low Replacement Cost:	<u>\$10,000</u>		
Remaining Component Life:	<u>N/A</u>	years				
Quantity Breakdown			General Description			
Location	Quantity	Unit	Cracking and chipping were noticed at the time of the inspection as seen in the included photos. Concrete panels should be repaired and or replaced when there are 3 or more cracks that extend the full depth of the slab or if there is spalling that covers more than 25% of the panel. Protruding edges should be ground down to prevent further damage and to prevent any safety hazards. Several locations of onsite concrete flatwork was cracked and spalling at the time of inspection. Utility companies should be notified to replace severely damaged concrete collars around valves and manholes.

Miscellaneous concrete repair	1	LS				
Special Notes, Comments, and Considerations						
Repairs to the entrance structure, pavers, and the rotunda structure on the east end of the development are assumed to be taken from this concrete repair allotment.

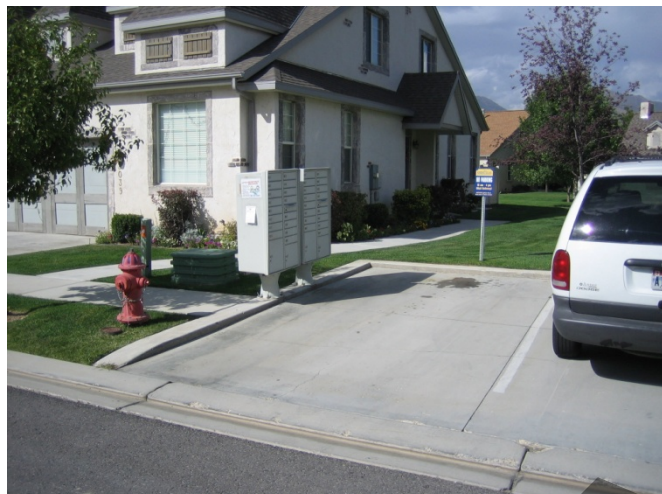
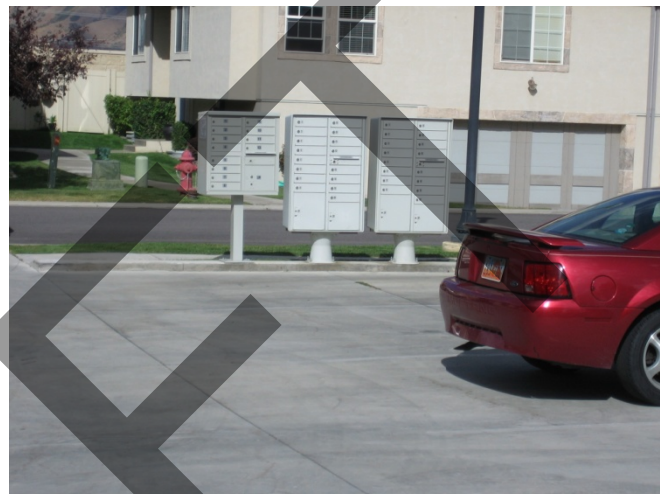
Component Name: Mailboxes  
 Component Number: Common Development 3001

The multi unit mail boxes were noted to be in relatively new condition. No visual damage could be seen at the time of inspection.

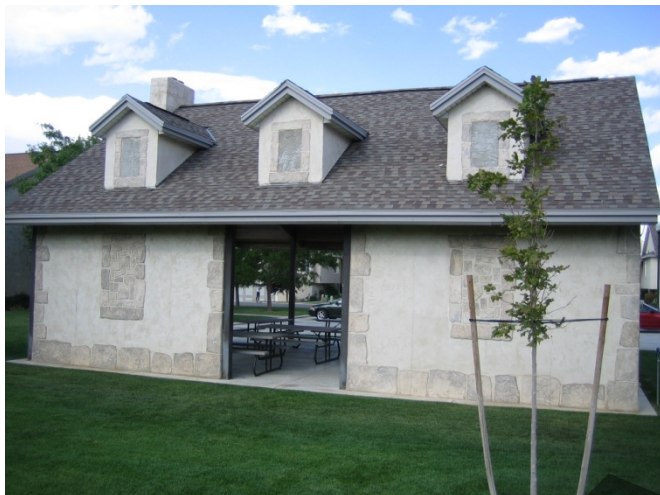
Component Name: Painting/Resurface  
 Component Number: Residential Building 2001

Component Duration			Component Cost	
Component Life Expectancy:	<u>10</u>	years	High Replacement Cost:	<u>\$ 6,552</u>
Age of Component:	<u>7</u>	years	Low Replacement Cost:	<u>\$ 5,964</u>
Remaining Component Life:	<u>3</u>	years		
Quantity Breakdown			General Description	
Unit Types	Quantity	Unit	<p>The current condition of the pavilion exterior is acceptable. No visible signs of premature aging or wear were apparent upon observation. A new coat of paint/refinish is recommended at 10-year intervals to preserve the exterior condition and aesthetics of the building.</p>	
Pavillion	2,100	sf		
Special Notes, Comments, and Considerations

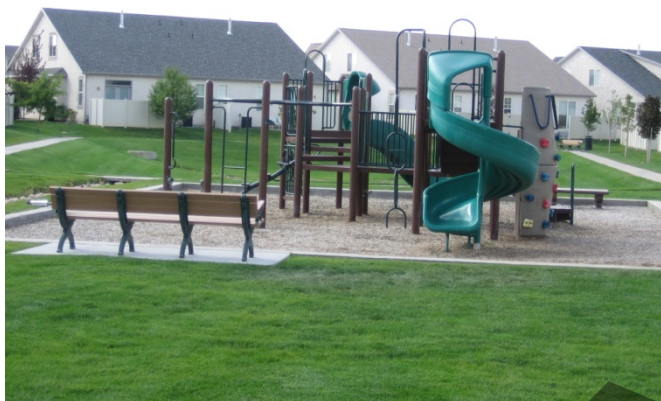
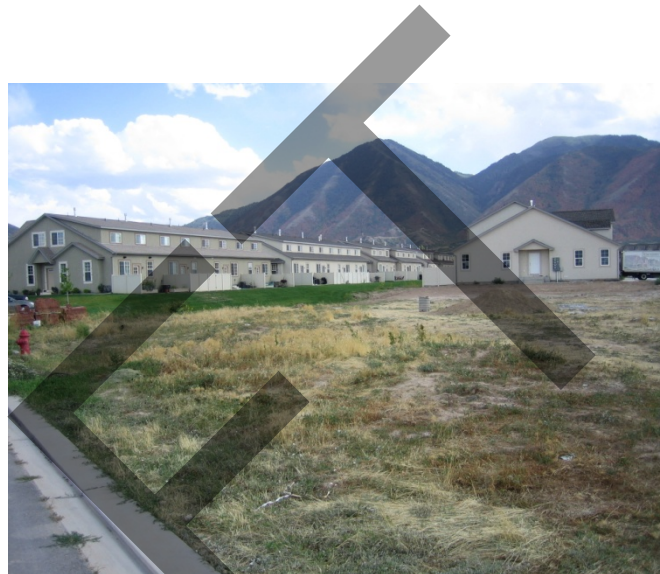
Component Name: Playground Equipment  
 Component Number: Recreation Equipment 6001

Component Duration			Component Cost	
Component Life Expectancy:	<u>16</u>	years	High Replacement Cost:	<u>\$ 12,000</u>
Age of Component:	<u>7</u>	years	Low Replacement Cost:	<u>\$ 10,500</u>
Remaining Component Life:	<u>9</u>	years		
Quantity Breakdown			General Description	
Name	Quantity	Unit	Commercial grade playground equipment appeared to be in relatively new condition with little to no damage.	
Play System	<u>2</u>	Each

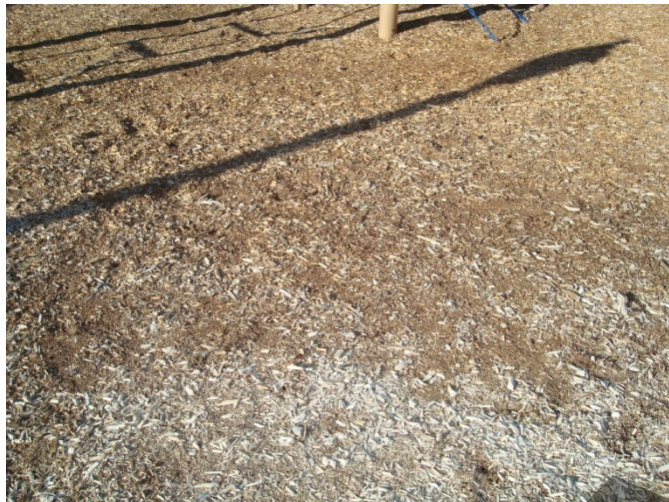
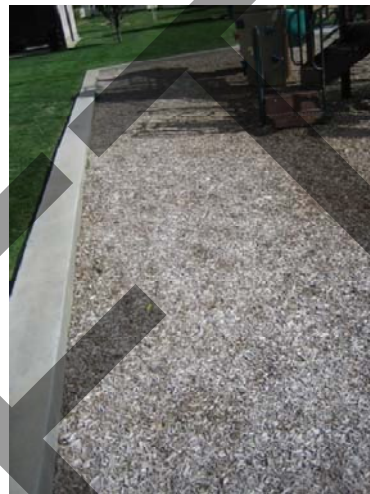
Component Name: Playground Groundcover  
 Component Number: Recreation Equipment 6002

Component Duration			Component Cost	
Component Life Expectancy:	<u>2</u>	years	High Replacement Cost:	<u>\$ 2,000</u>
Age of Component:	<u>5</u>	years	Low Replacement Cost:	<u>\$ 1,600</u>
Remaining Component Life:	<u>0</u>	years		
Quantity Breakdown			General Description	
Name	Quantity	Unit	Playground covering consisted of wood mulch. Playground covering should be no less than 6 inches deep. The covering appeared to be degraded and is nearing the end of its design life. Replacement in the near future is recommended.	
Playground Mulch	4,000	Sq. Ft.		
Special Notes, Comments, and Considerations

According to this analysis, replacing the playground cover should occur this year, 2010.

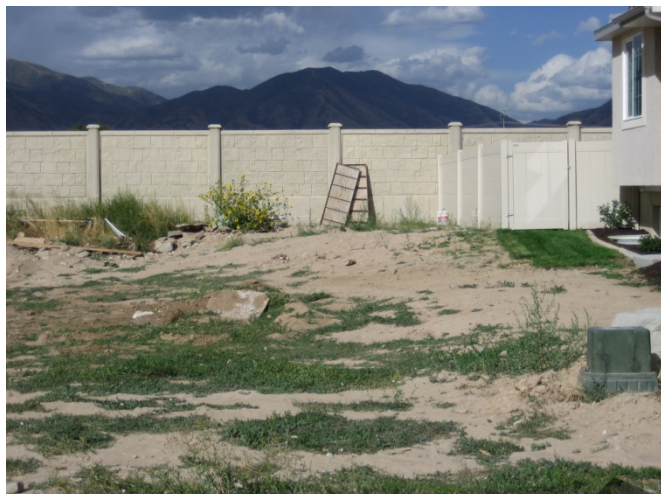
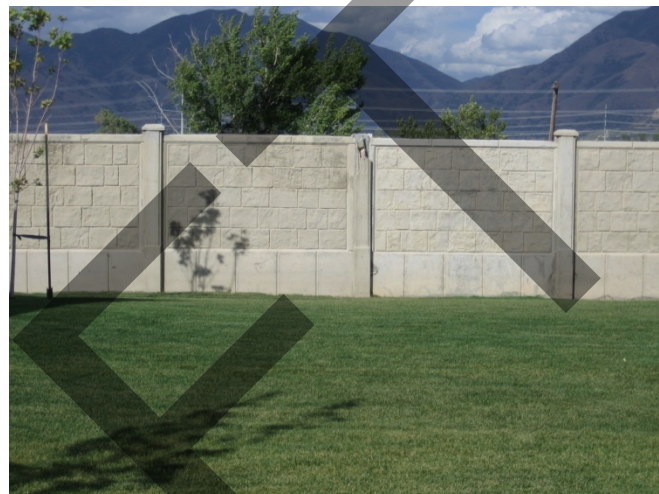
Component Name: Concrete Panel Privacy Fencing  
 Component Number: Common Development 3002

8-ft high concrete panel privacy fence was observed surrounding the community. One of the vertical braces was broken, as shown in the photograph on the right. An allotment of 500 lineal feet was provided for future repairs.

The cost of replacing the entire fence is high, and would drive the economics of this analysis. It is assumed the wall will be acceptable over the timeframe of this study. It is likely, in a future update of this report, the entire length of fence will need to be replaced.

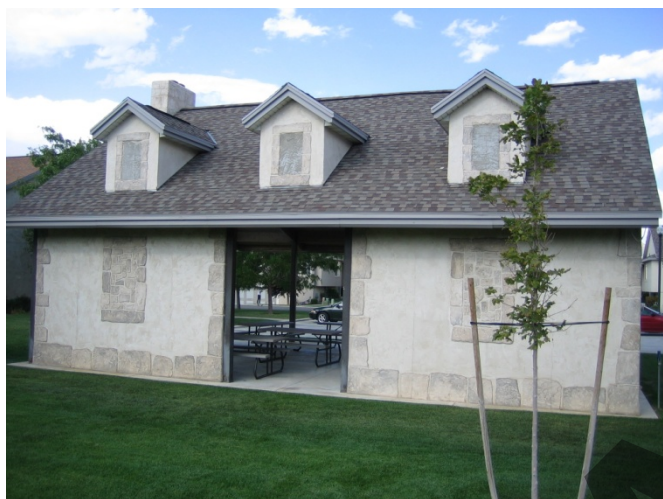
Component Name: Roof  
 Component Number: Residential Building 2002

Component Duration			Component Cost	
Component Life Expectancy:	<u>30</u>	years	High Replacement Cost:	<u>\$ 5,520</u>
Age of Component:	<u>7</u>	years	Low Replacement Cost:	<u>\$ 5,200</u>
Remaining Component Life:	<u>23</u>	years		
Quantity Breakdown			General Description	
Type	Quantity	Unit	The roof was installed in 2003 and from the ground appears sound. Observation reveal the shingles are free from warping, curling, cracking, or any other sign of premature wear.	
Pavillion	1,600	sf		
Special Notes, Comments, and Considerations

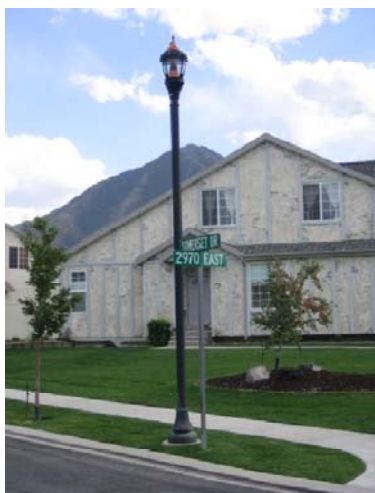
Component Name: Light Poles  
 Component Number: Common Development 3003

Component Duration			Component Cost	
Component Life Expectancy:	<u>20</u>	years	High Repair Cost:	<u>\$ 10,472</u>
Age of Component:	<u>7</u>	years	Low Repair Cost:	<u>\$ 8,272</u>
Remaining Component Life:	<u>13</u>	years		
Quantity Breakdown			General Description	
Name	Quantity	Unit	Light poles appeared to be in proper condition – no signs of vandalism, or premature wear. It is estimated that the light poles will need to be replaced every 20 years.	
Full Height Light Pole	11	Each		
Special Notes, Comments, and Considerations

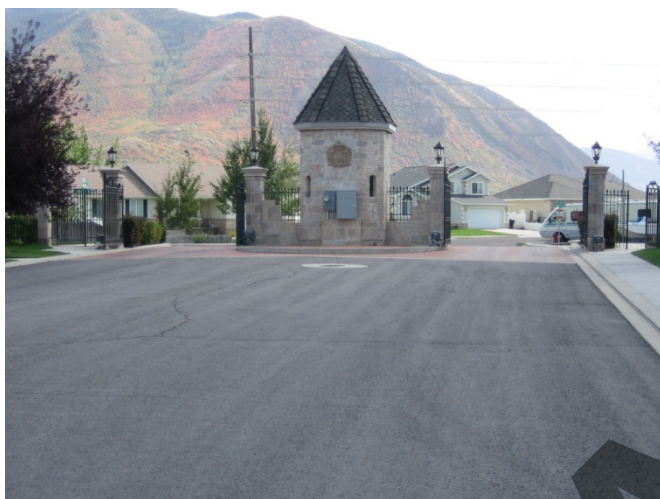
Component Name: Gates  
 Component Number: Security 5004

Component Duration			Component Cost	
Component Life Expectancy:	<u>15</u>	years	High Repair Cost:	<u>\$ 20,000</u>
Age of Component:	<u>7</u>	years	Low Repair Cost:	<u>\$ 12,000</u>
Remaining Component Life:	<u>8</u>	years		
Quantity Breakdown			General Description	
Name	Quantity	Unit	A gated entrance was observed at the east community access. The entrance appears to be in good working order, free of premature corrosion or aging. Each gate includes an automatic swing opener. The gates do not appear to be used, and thus may have a longer life expectancy, assuming they have been properly maintained.	
Gates at East Entrance	4	Each

The gates and openers are not currently being used; however in the future an additional gated entrance will be added to the west, and at that time the community will be accessed strictly through the gated entrance. YKL recommends updating the report when the additional gated entrance is constructed.
